Manhole Inspection Summary

Manhole # S65O__011MH

Location Address: **6202 Boston St.**

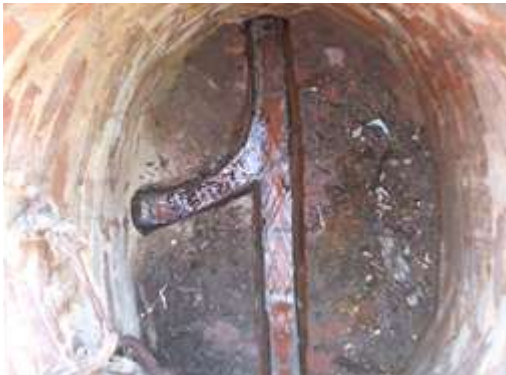
Top View

Condition: ☐ Sound ☐ Cracked ☐ Root Intrusion ☒ **Loose Brick** ☒ **Deteriorated**

Infiltration: ☐ None ☒ **Joint** ☐ Cracks ☒ **Mortar** ☐ Roots ☐ Wall
